Manhole Inspection Summary

Manhole # S170__005MH

Insp Date: **3/7/08 11:44 AM**

Location Address: **2419 wilkens-alley-christian**

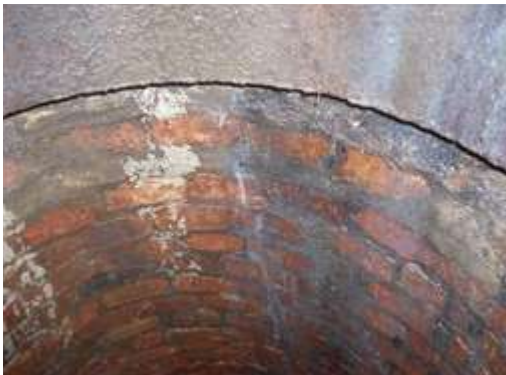
Defect 3

Infiltration: ☐ None ☒ **Joint** ☐ Cracks ☐ Mortar ☐ Roots ☐ Wall

infiltration evidence at the corbel joint

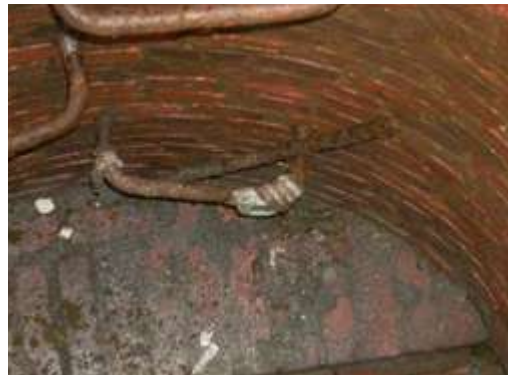
Defect 2

Surcharge ☒ **Evidence Of Surcharge** Depth: **3** (ft.) ☐ Active Surcharge Present

surcharge evidence on the step

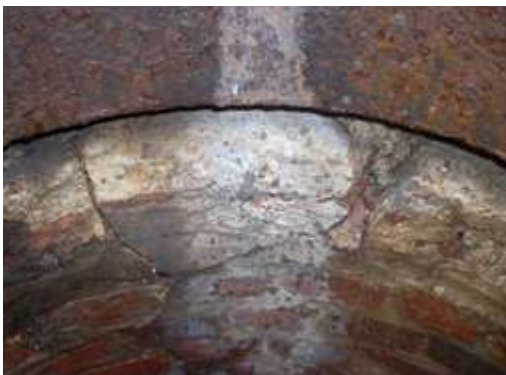
Defect 1

Condition: ☐ Sound ☒ **Cracked** ☐ Root Intrusion ☐ Loose Brick ☐ Deteriorated

cracked corbel

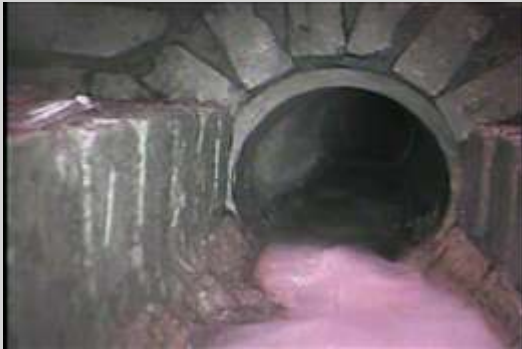
12 O'Clock Outflow

8 in. Circular Gravity Sewer
Pipe Out @ 12 O'Clock

Pipe Height: **7.2** (in.) Rod and Bar (Angled)
Pipe Material: **Clay** ☐ Pipe Lined
Invert Depth: **8.90** (ft.) Flow Characteristics: **Slow**
Deposits: ☒ None ☐ Mud ☐ Sludge ☐ Debris ☐ Grease
Silt Depth: **0** (in.) Deposits Extent:
Infiltration: **None** Pipe Seal Cond: **Sound**

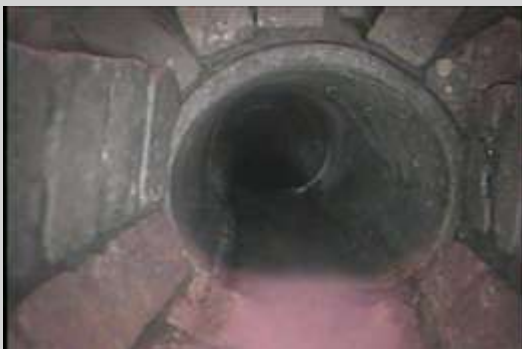
6 O'Clock Inflow

8 in. Circular Gravity Sewer
Pipe In @ 6 O'Clock

Pipe Height: **8.4** (in.) Rod and Bar (Angled)
Pipe Material: **Clay** ☐ Pipe Lined
Invert Depth: **8.81** (ft.) Flow Characteristics: **Slow**
Deposits: ☒ None ☐ Mud ☐ Sludge ☐ Debris ☐ Grease
Silt Depth: **0** (in.) Deposits Extent:
Infiltration: **None** Pipe Seal Cond: **Sound**
